ವಿಷಯ: ಪಿನಾಕಿನಿ ಎಜುಕೇಶನಲ್ ಟ್ರಸ್ಟ್, ರೈಮಂಡ್ಸ್ ಫ್ಯಾಕ್ಟರಿ ಹಿಂಭಾಗ, ಬೈಪಾಸ್ ರಸ್ತೆ ಗುಂಡಾಪುರ ಗೌರಿಬಿದನೂರು ತಾಲ್ಲೂಕು, ಚಿಕ್ಕಬಳ್ಳಾಪುರ ಜಿಲ್ಲೆ ಕಟ್ಟಡಕ್ಕೆ ಸುರಕ್ಷತಾ ಪ್ರಮಾಣ ಪತ್ರ ನೀಡುವ ಬಗ್ಗೆ.

REPORT NO : TSB/107/2024 – 2025

**SAFETY CHECK REPORT ON EXISTING SCHOOL
BUILDING OF PINAKINI EDUCATIONAL TRUST
BEHIND RAYMOND FACTORY , BYPASS ROAD GUNDAPURA,
GOWRIBIDANUR – 561208 CHIKKABALLAPUR.**

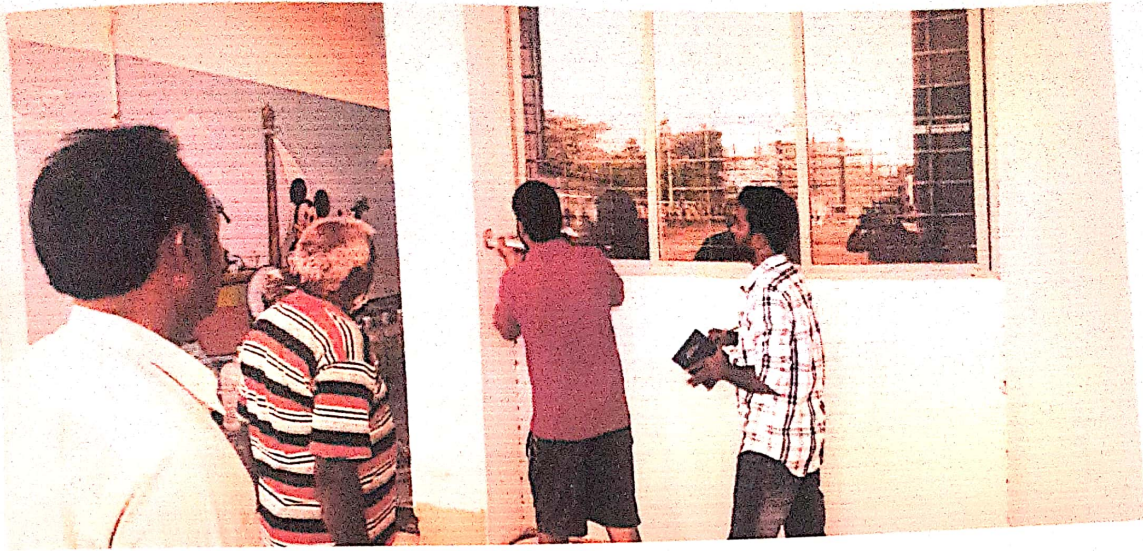
OBSERVATIONS : NDT TEST FOR COLUMN

REMARKS : WITH GUIDANCE OF PWD ENGINEER

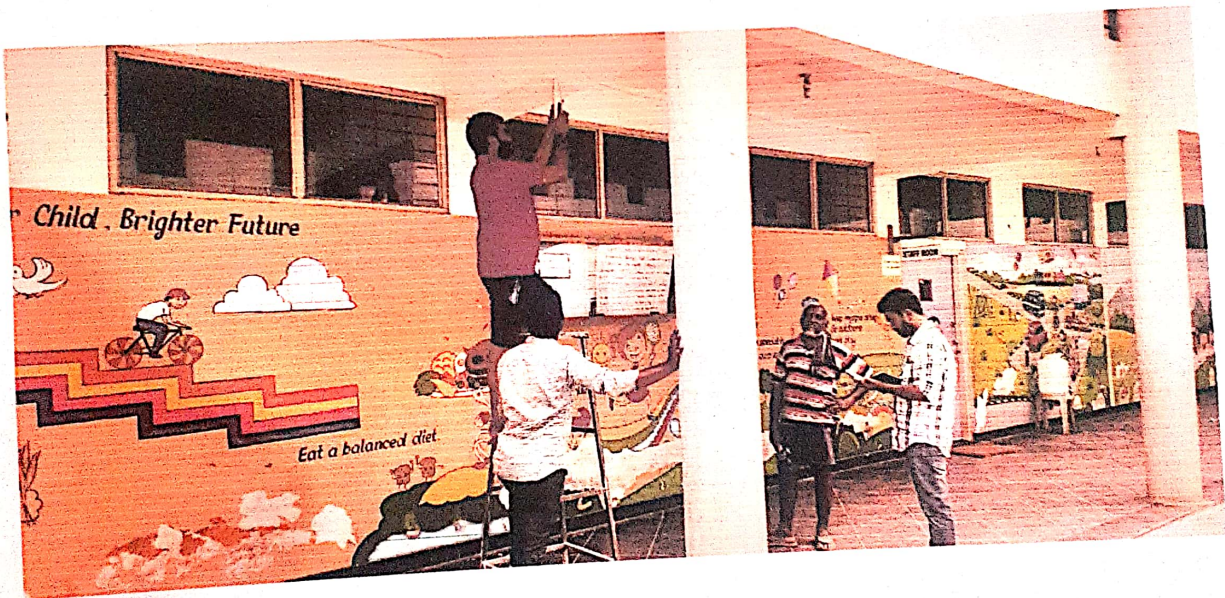
OBSERVATIONS : NDT TEST FOR BEAM

REMARKS : WITH GUIDANCE OF PWD ENGINEER

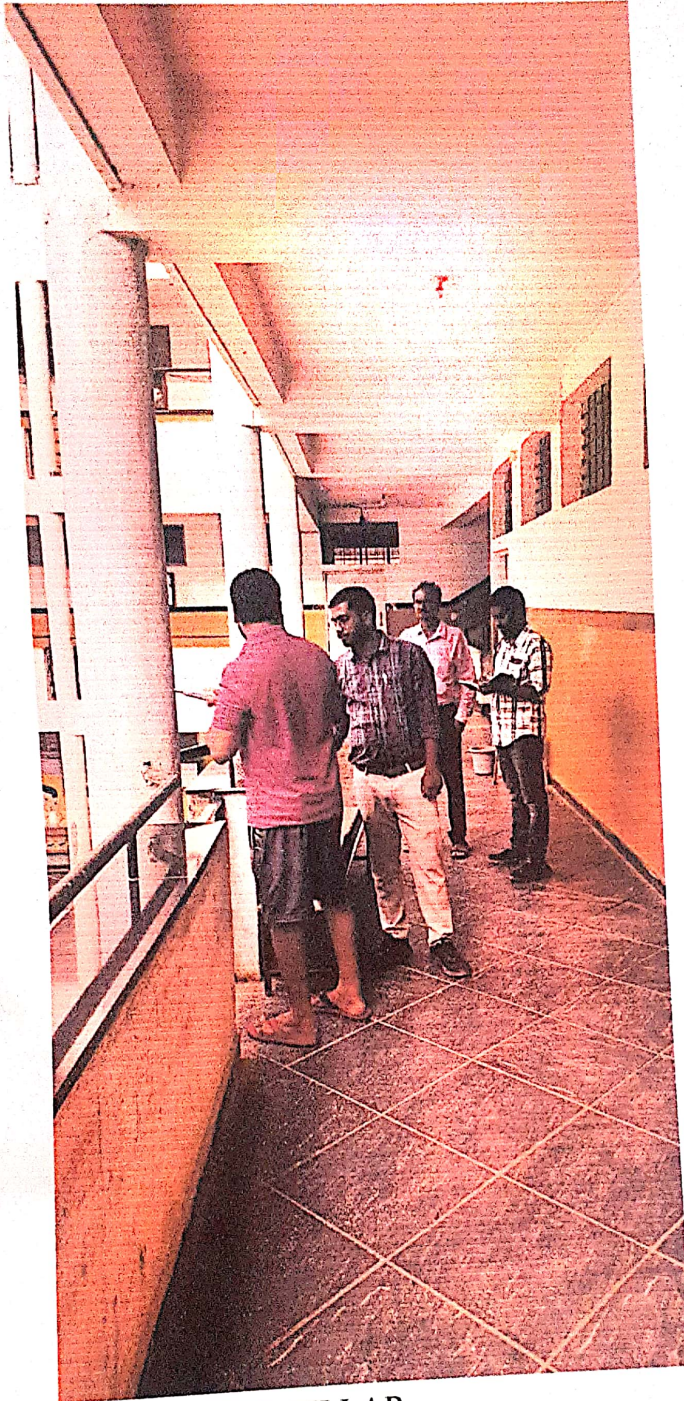
OBSERVATIONS : NDT TEST FOR PILLAR

REMARKS : UNDER THE GUIDANCE OF PWD ENGINEER
